**Estudios sobre
Arte Actual**

**Número 4
Julio de 2016**

Lost heritage buildings in Cuenca-Ecuador: Historical analysis of the “Villa Roselena, in El Ejido of Cuenca”

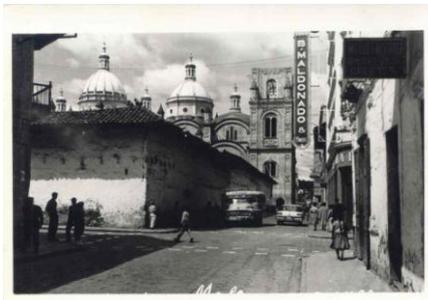
This is a colonial monastery with enclosure walls (no windows and doors) that closed the block located diagonally from the Cuenca's Central Park: “Calderón Park”. In the 70's, wide gardens and colonial buildings disappeared to make room for buildings with more than two floors without any value right in the middle of the Historical Center of city.

Fig.1. Enclosure wall of the Monastery “El Carmen de la Asunción”.
Source: Collection “Fundación El Barranco”

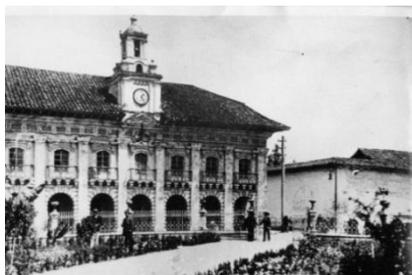
The demolition of the Old Municipality Building is one of the examples of what happened in the city between 1950 and 1960. During this time several buildings were demolished, since they were considered old, dirty, unhealthy and unusable. A modern building was built in its place, designed by the Uruguayan architect Gilberto Gato Sobral.

Fig. 2. The Old Municipality Building.
Source: Collection “Fundación El Barranco”

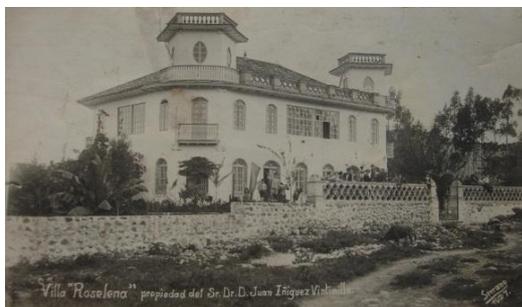
Fig. 4. La Villa Roselena.
Source: Collection "Fundación El Barranco"

Juan Íñiguez Vintimilla built the house (1922) in the avenue Solano, very close to the "Benigno Malo" High School. It caused the admiration and concern of his friends, for risking to live in "the middle of the wilderness", like they were used to say in that time. It is the photographer Serrano who, in the year 1927, immortalized the mansion in a historical

photograph (Fig. 4), in which one clearly notices that the landscape around the mansion has a unique characteristic vegetation, without other buildings in its surroundings (“La villa Roselena” 1).

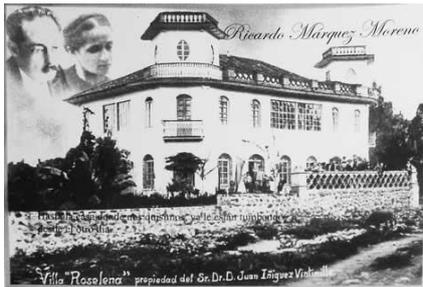
Fig. 5. The former Villa Roselena.
Source: Collection “Fundación El Barranco”

The walls of the Villa Roselena were constructed of adobe for the lower part and bahareque for the higher part. The walls have a width of 1,20m so that the constructive system could have been combined between bearing walls of adobe and partition walls of bahareque. The walls and the ceiling were almost completely covered with paintings (murals). The structure of the roof was of wood and covered by tiles.

From the characteristics of this building one can say that its construction was a transitional period between the colonial and republican architecture. Indeed, it has colonial characteristics such as the use of materials like adobe, wood and tile. On the other hand, it is a pioneer of a new type of architecture: the republican, in which the technology allows for the presence of large windows to enable the entry of light into the rooms, using in some cases arches. Furthermore, it has a lobby that distributes the circulation at the entrance of the building. This differs from the colonial architecture, in which the patio was the circulation hub for the entrance to all rooms.

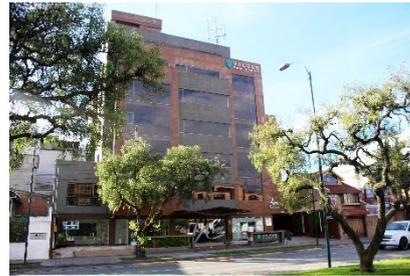
Fig. 6. The current building Valgus
Source: Rosa Pintado

At the death of Madam Rosa Elena Arteaga, the building stayed in hands of her heirs, who later on sold the property. The “villa Roselena” was demolished on May 1st 2008 and a new multi-story building “Valgus” took its place.
